# **Selected Images of the Effects of the October 15, 2006, Kīholo Bay-Māhukona, Hawai‘i, Earthquakes and Recovery Efforts**

Data Series 506

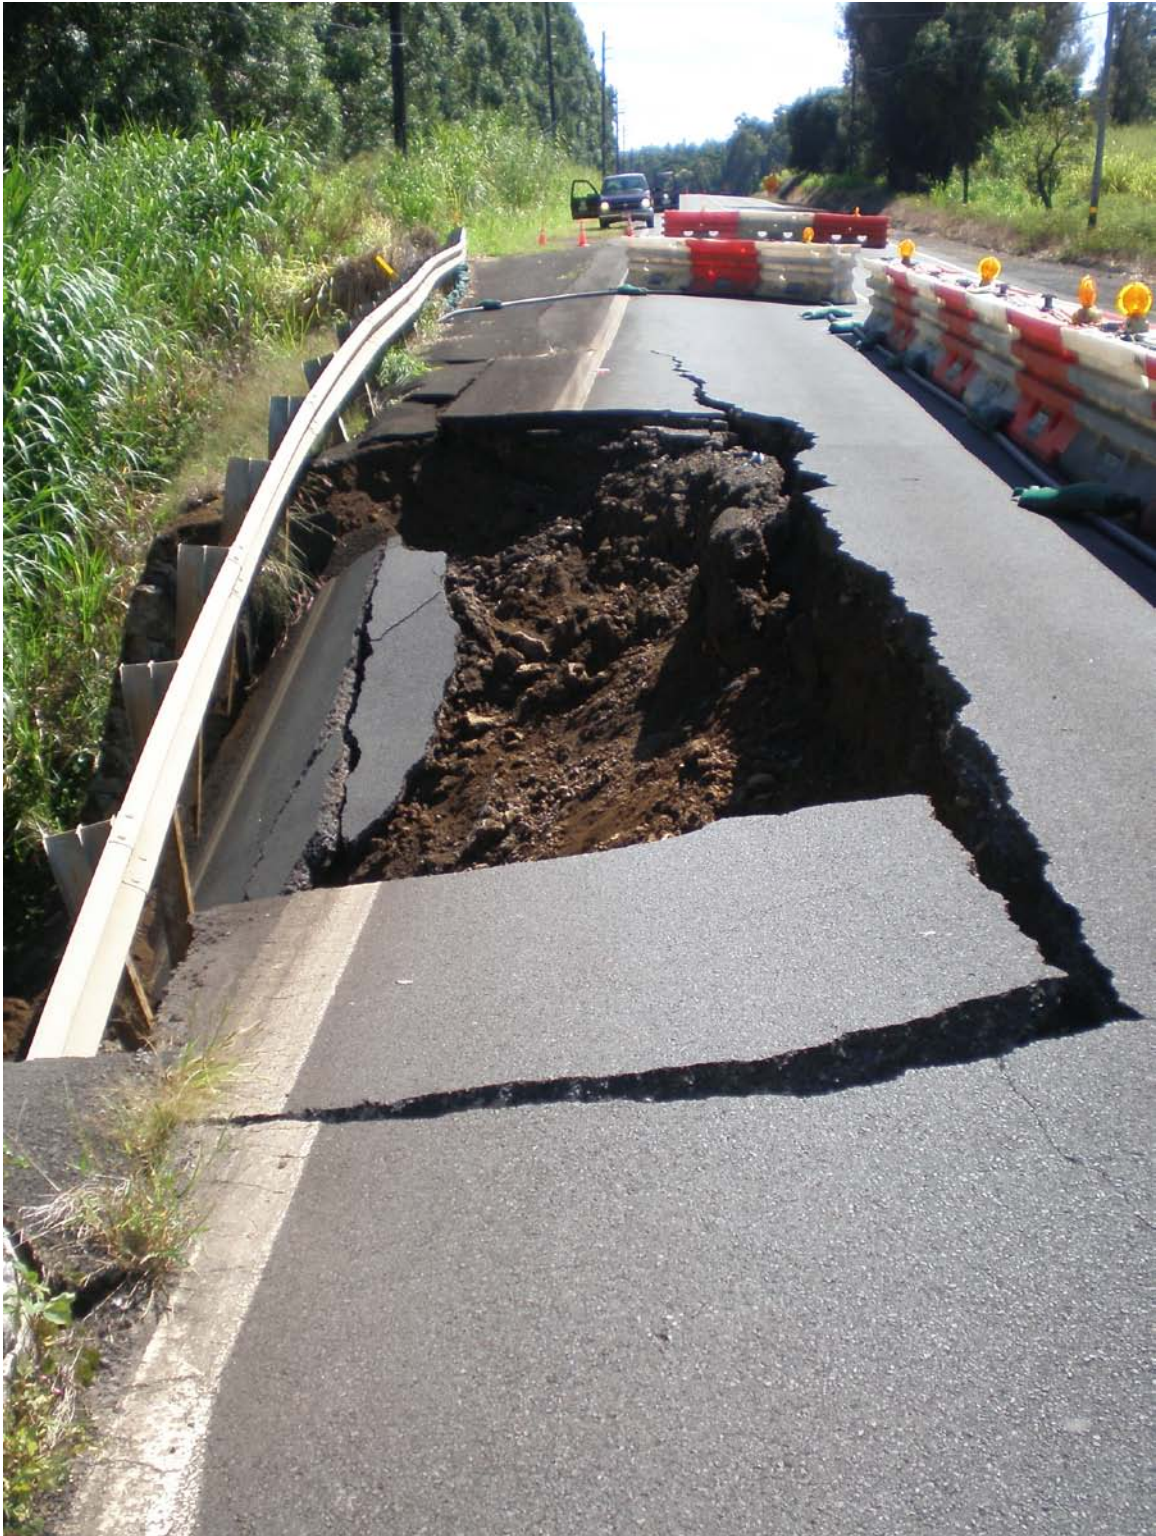
2.2. View of the collapsed section of Highway 19, approaching Kawāili Bridge from the southeast. Barricades and intermittent lights warn motorists away from the damaged area (view to the southeast). USGS photo by C. Francos, 10/17/2006 (cf018).

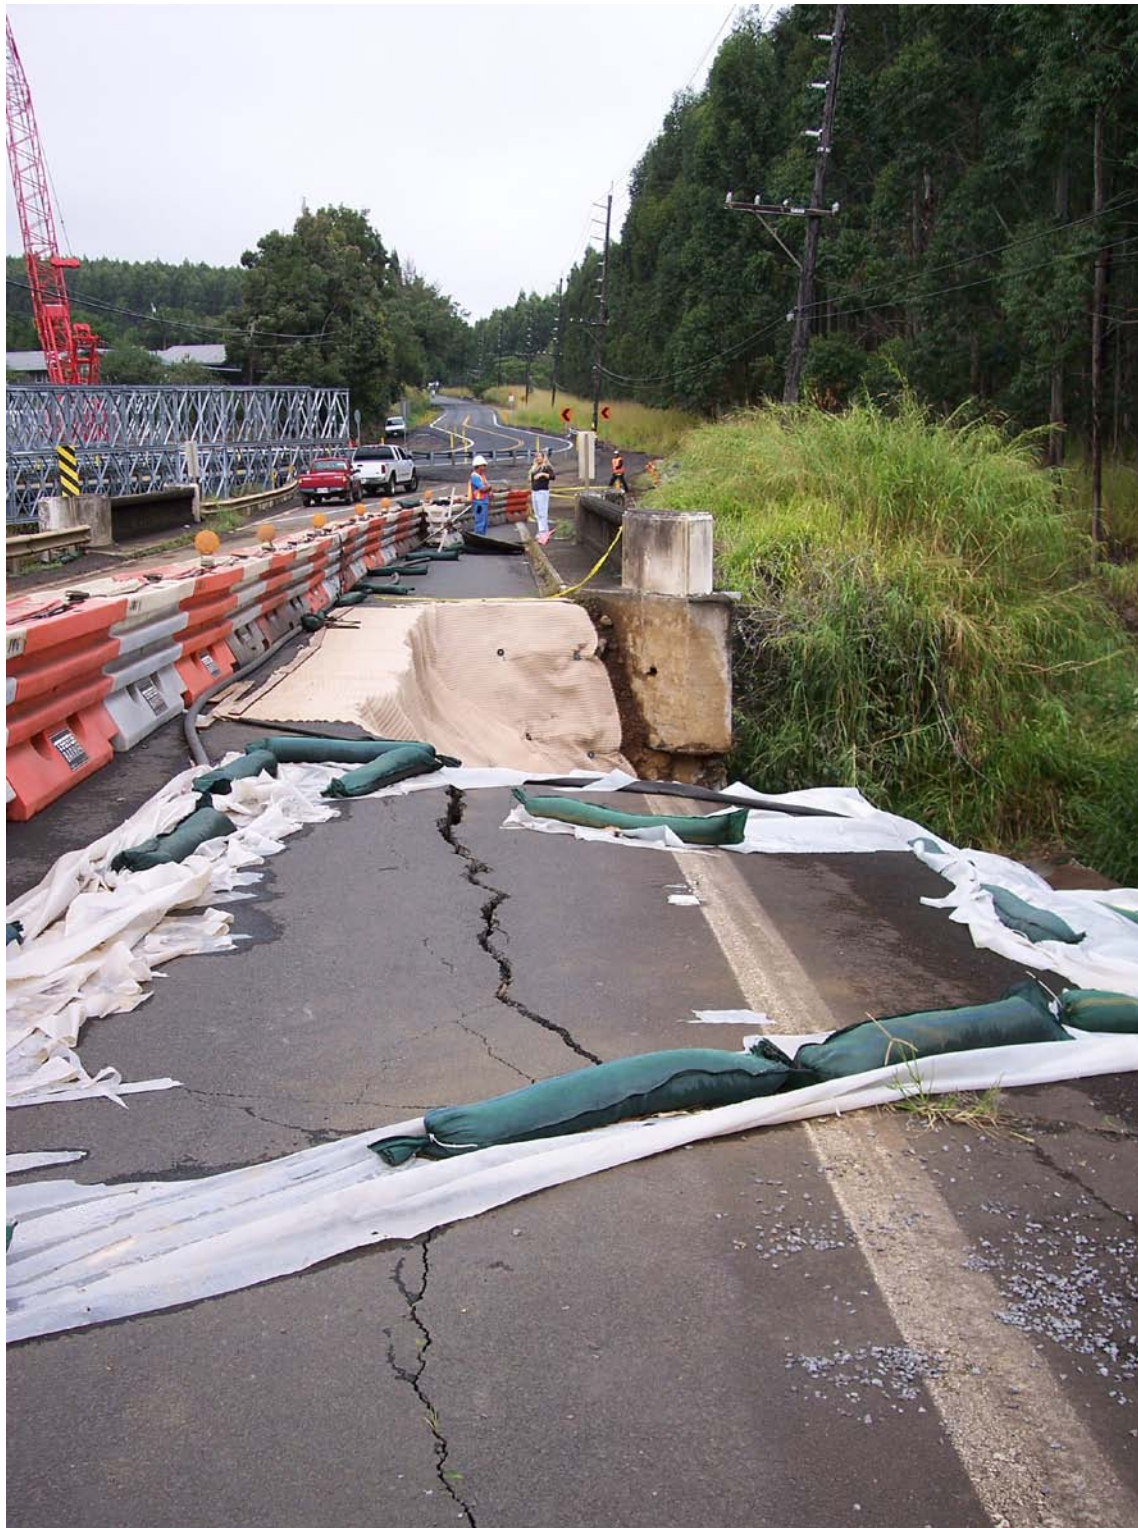
2.7. View of the cracked asphalt at the approach to the bridge from the southeast. The plastic sheeting, temporarily used to cover the failed slope, was replaced by a more durable nylon-polymer cloth (in center of photo). Construction of the bypass-road bridge is in progress (left rear of photo; view to the northwest on Highway 19). USGS photo by T.J. Takahashi, 2/9/2007 (tjt2480).

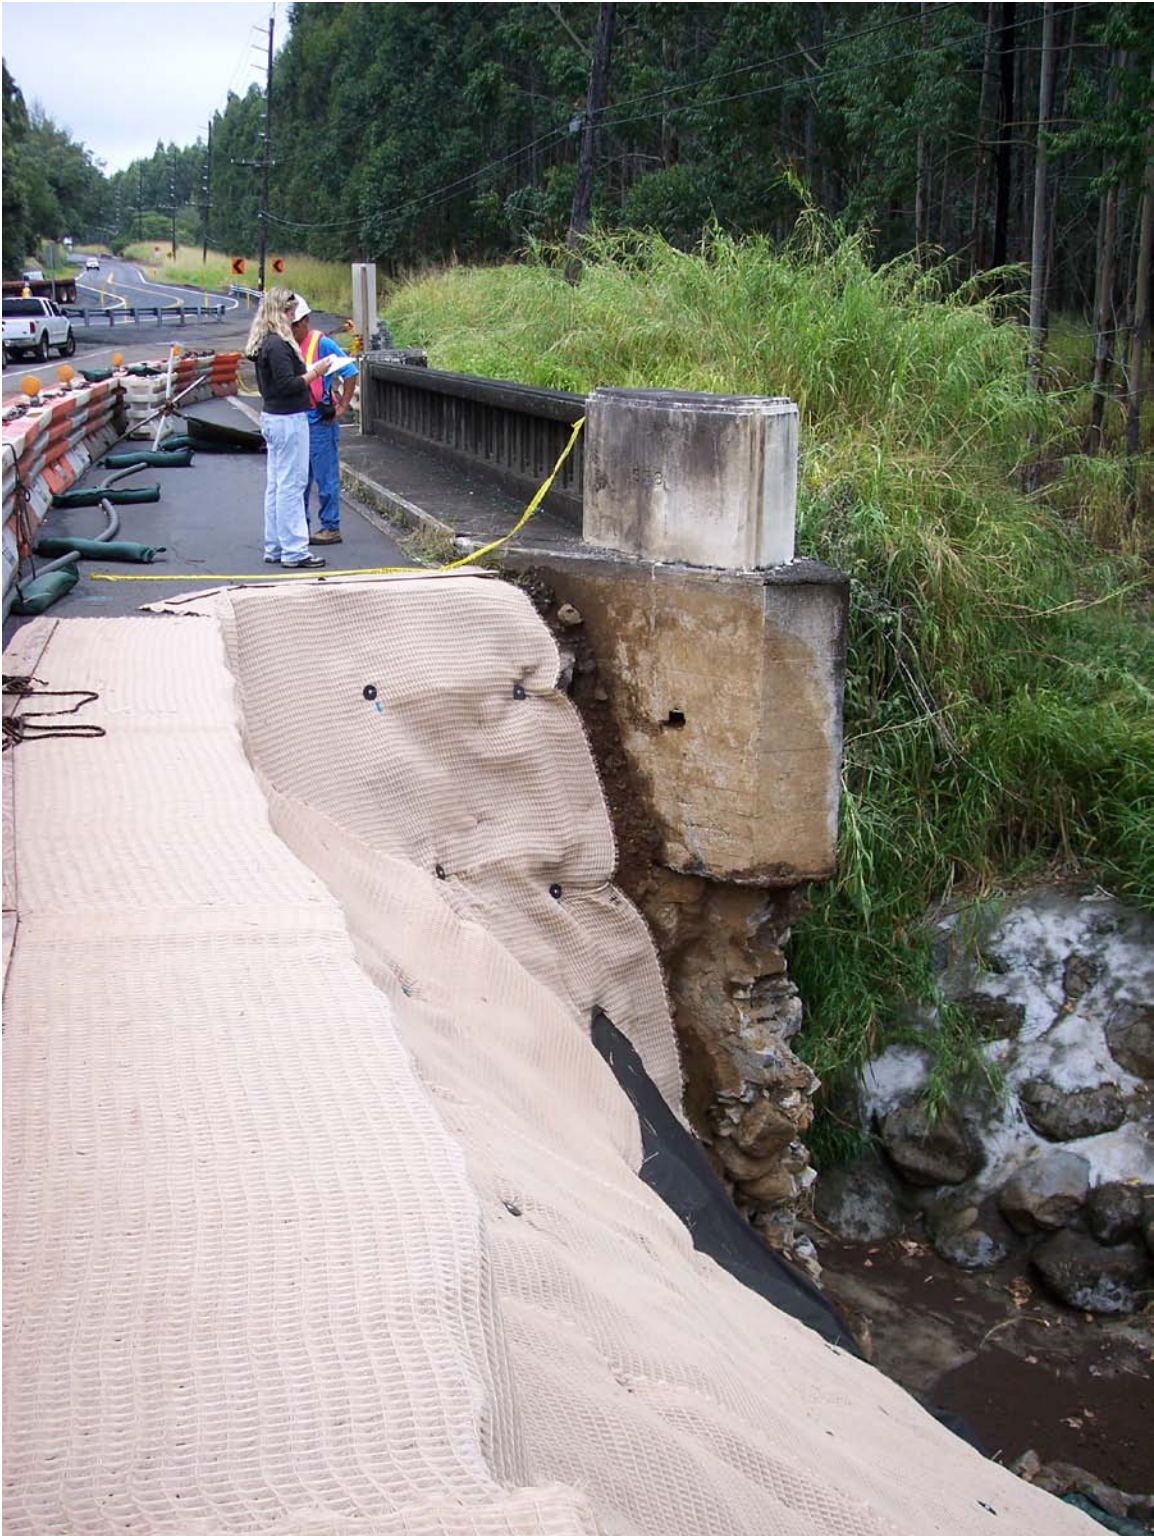
2.8. View of the failed slope, covered with the nylon-polymer cloth to prevent erosion. The collapsed abutment to the bridge is visible below the concrete railing (view to the northwest on Highway 19). USGS photo by T.J. Takahashi, 2/9/2007 (tjt2476).

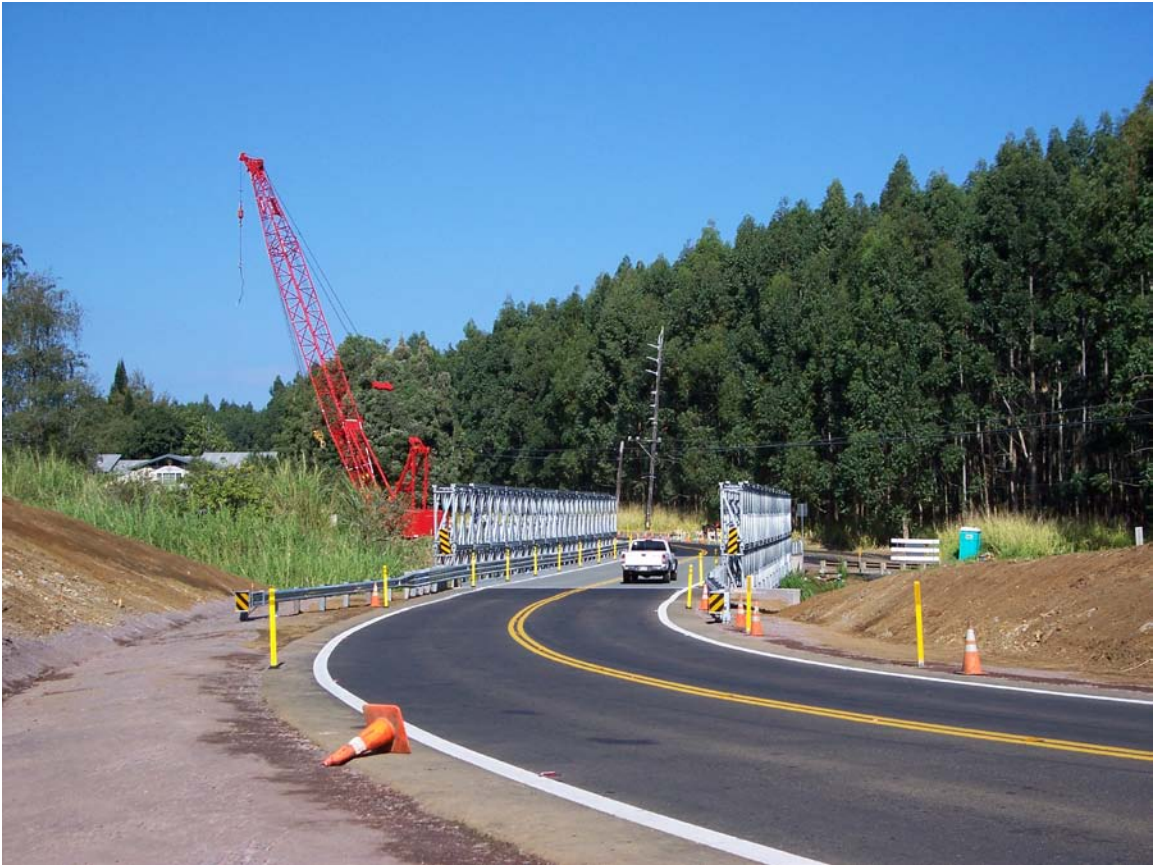
2.11. View of the bridge for the bypass road, completed and opened to traffic (view to the northwest on Highway 19). USGS photo by T.J. Takahashi, 2/4/2007 (tjt2387).

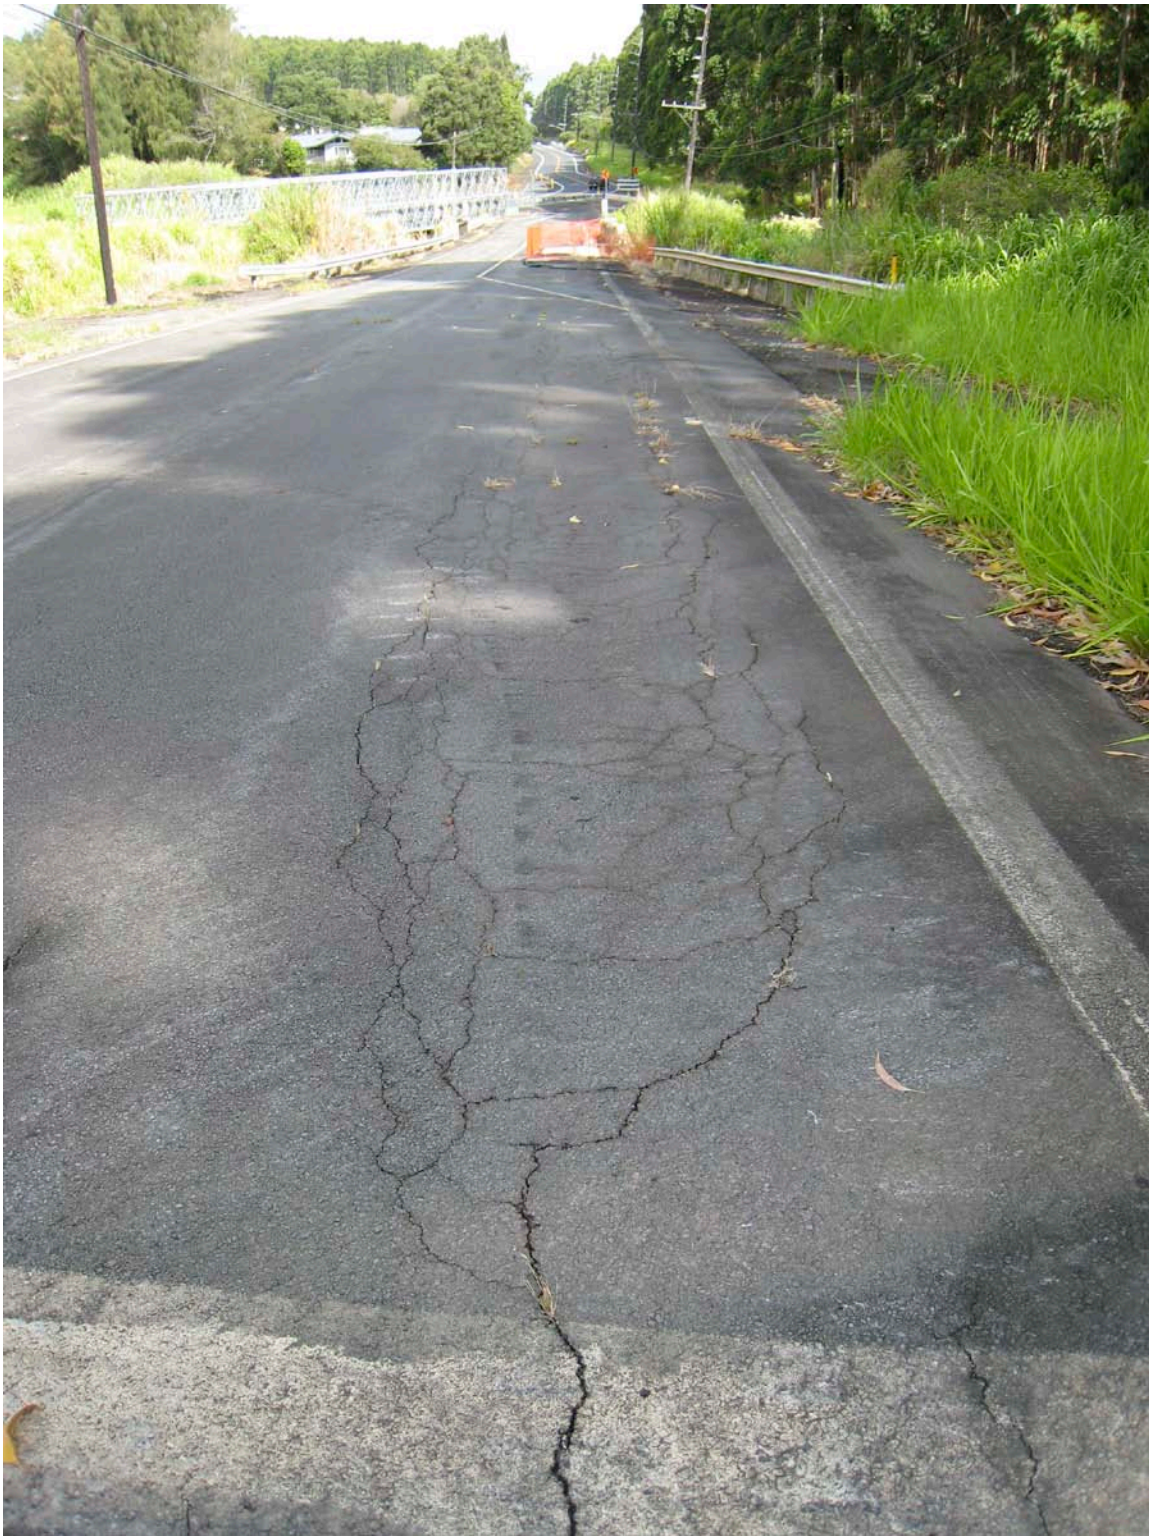
2.13. View of the damaged section of Highway 19 (approaching Kawāili Bridge from the southeast), riddled with cracks (view to the northwest). USGS photo by T.J. Takahashi, 7/19/2009 (tjt1385).

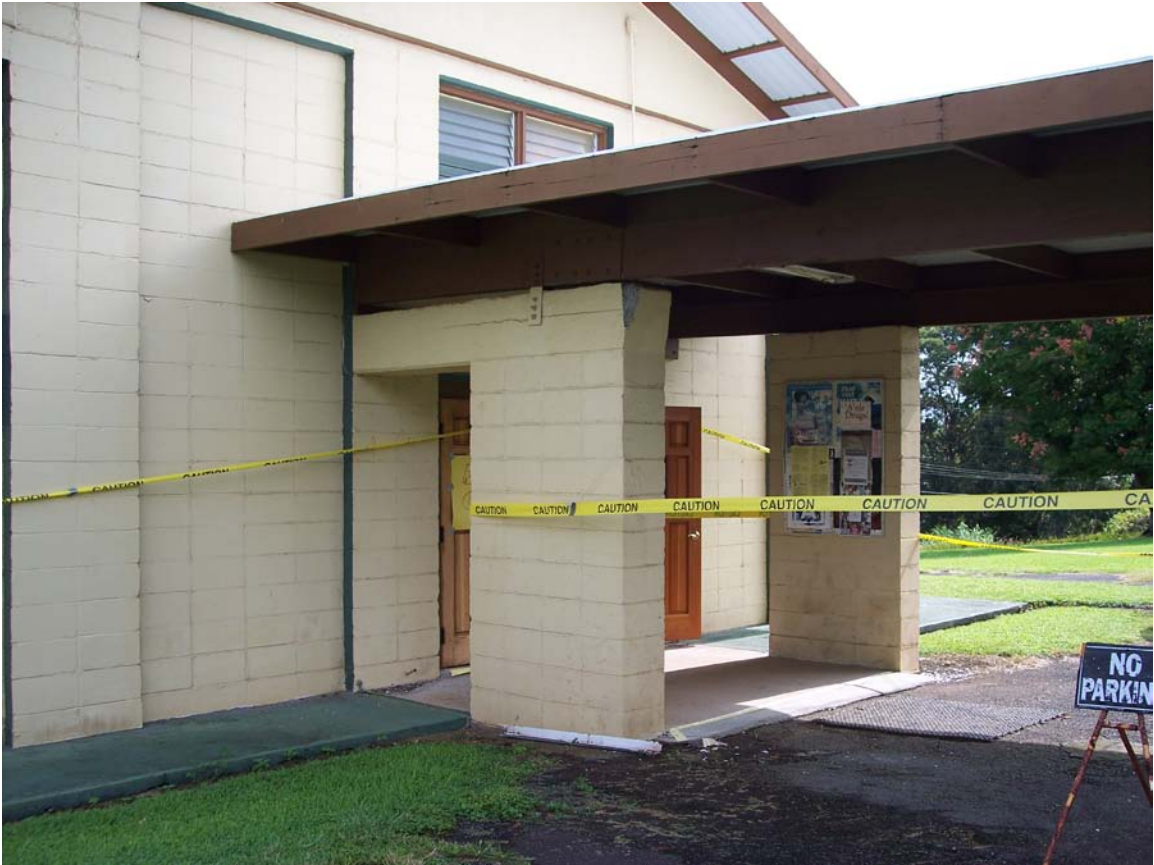
3.2. View of cracks in the concrete-block pillar and separation of the wooden overhang beam from the pillar in the covered entrance (view to the northeast). USGS photo by T.J. Takahashi, 10/20/2006 (tjt1154).

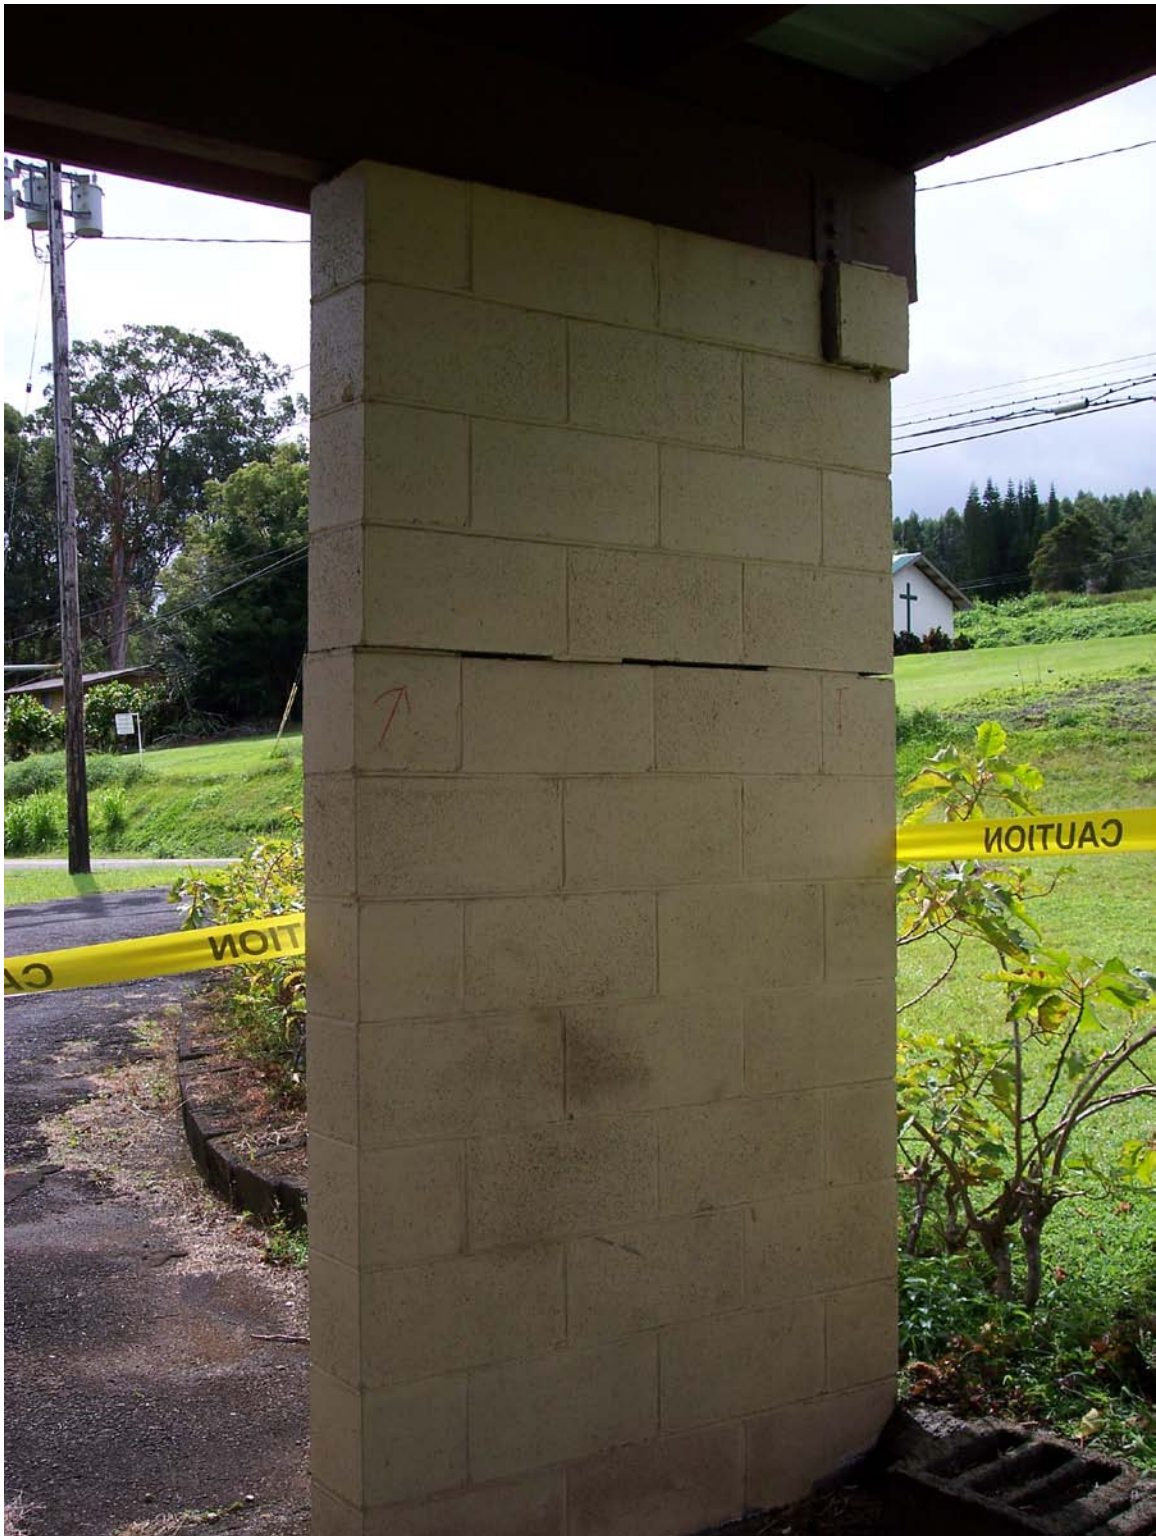
3.5. View, under the covered driveway, of an offset hollow tile block at the top of the concrete-block pillar and of cracks in the mortar between rows of reinforced hollow tile blocks (view to the southeast). USGS photo by T.J. Takahashi, 10/20/2006 (tjt1218).

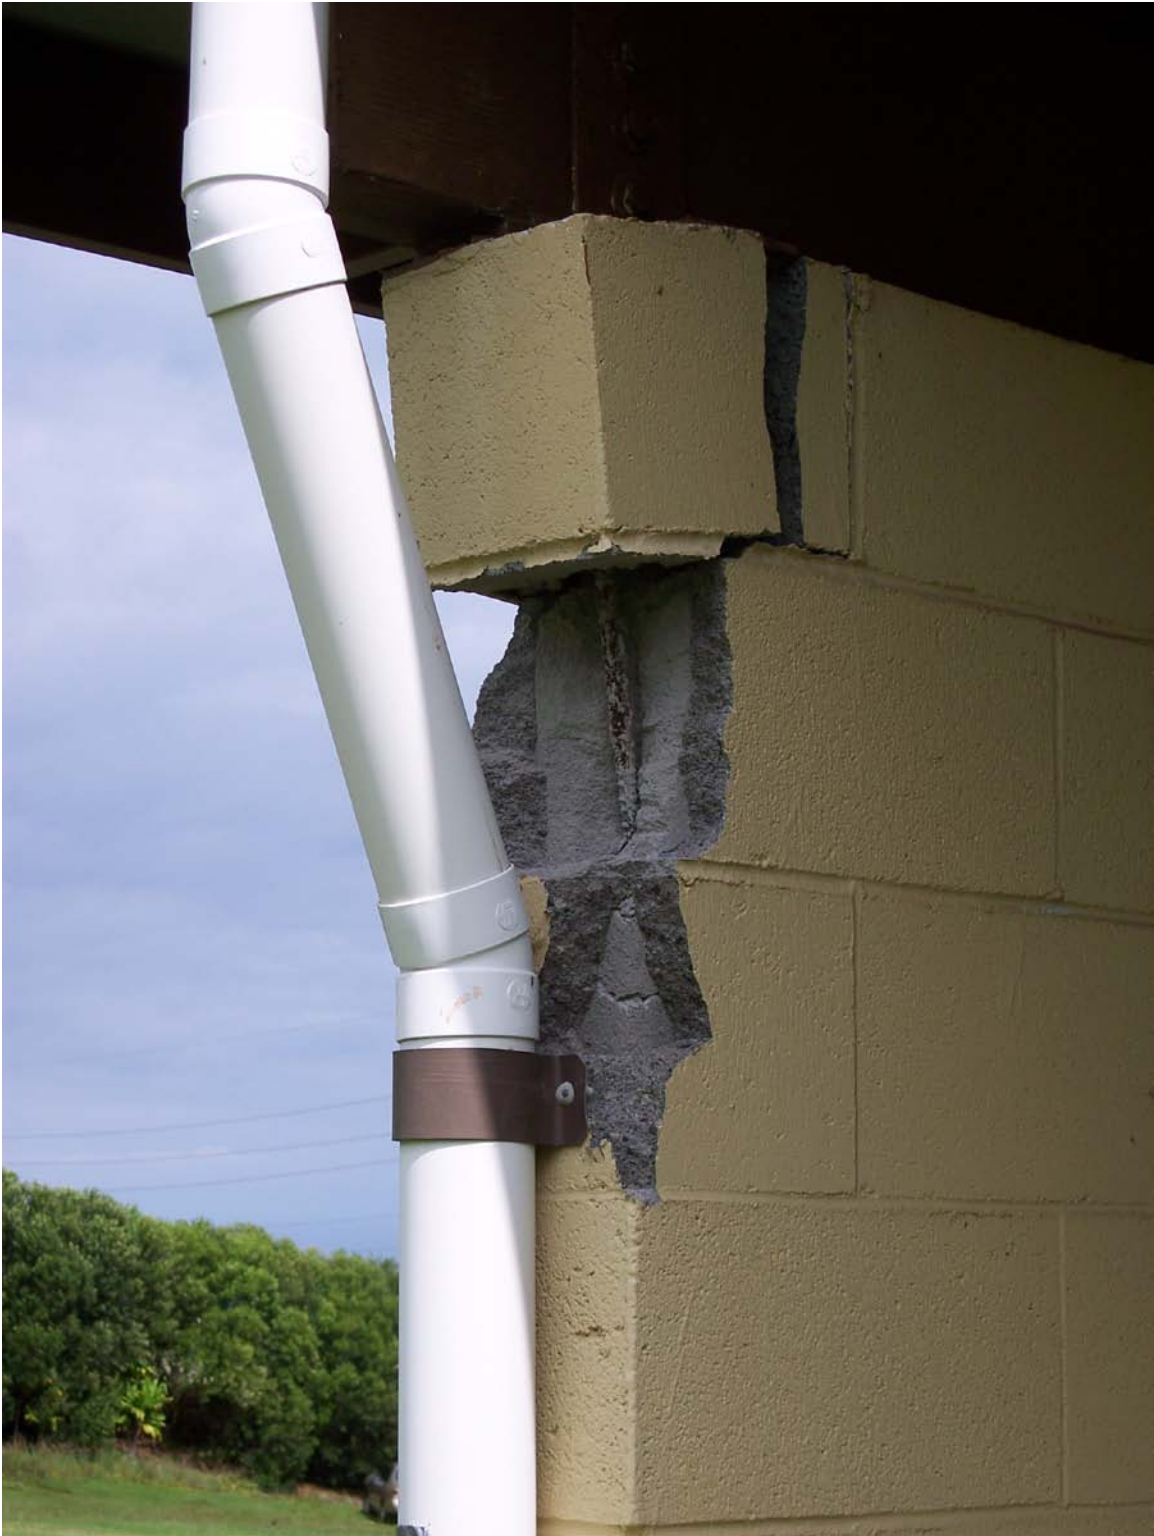
3.6. Close-up view of damage in the covered driveway: cracked and dislodged hollow tile block (held up by the downspout, seen in photo 3.5 (tjt1218)) and beneath it, cracked hollow tile blocks with exposed rebar (view to the southwest). USGS photo by T.J. Takahashi, 10/20/2006 (tjt1221).

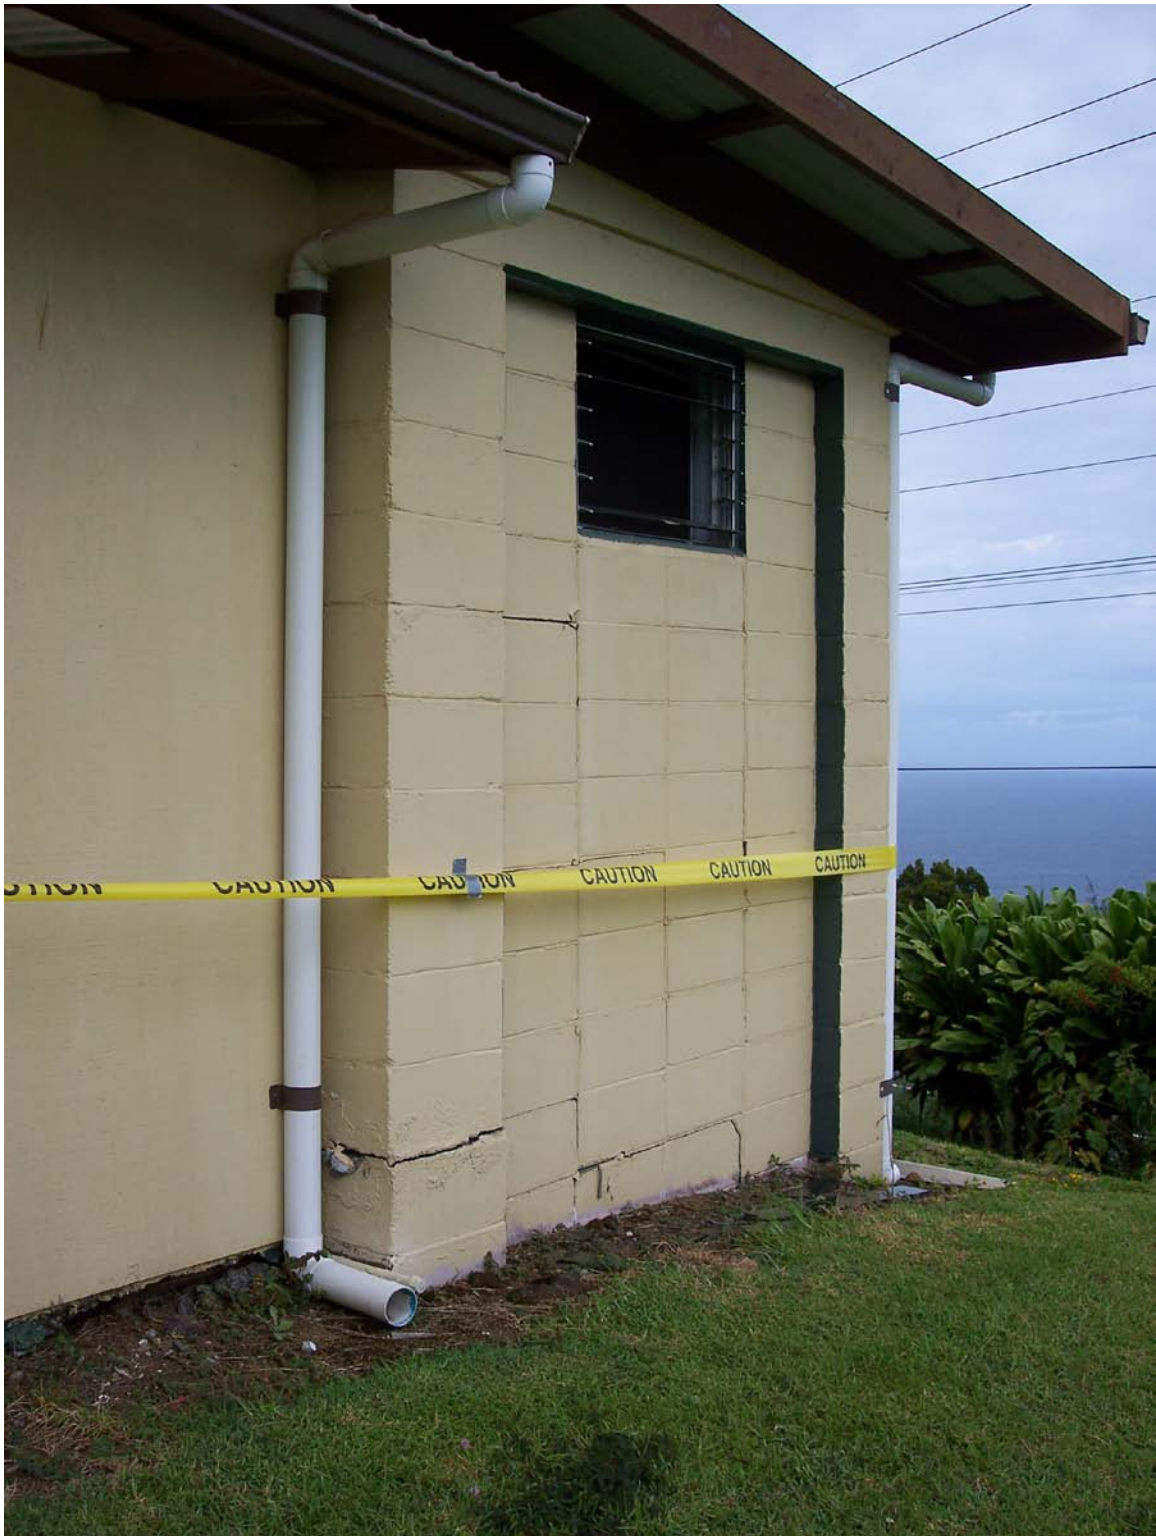
3.8. View of cracks in the mortar (between reinforced hollow tile concrete blocks), caused by shaking and ground slumping. The slumping caused the separation of the building from the ground (view to the northwest). USGS photo by T.J. Takahashi, 10/20/2006 (tjt1179).

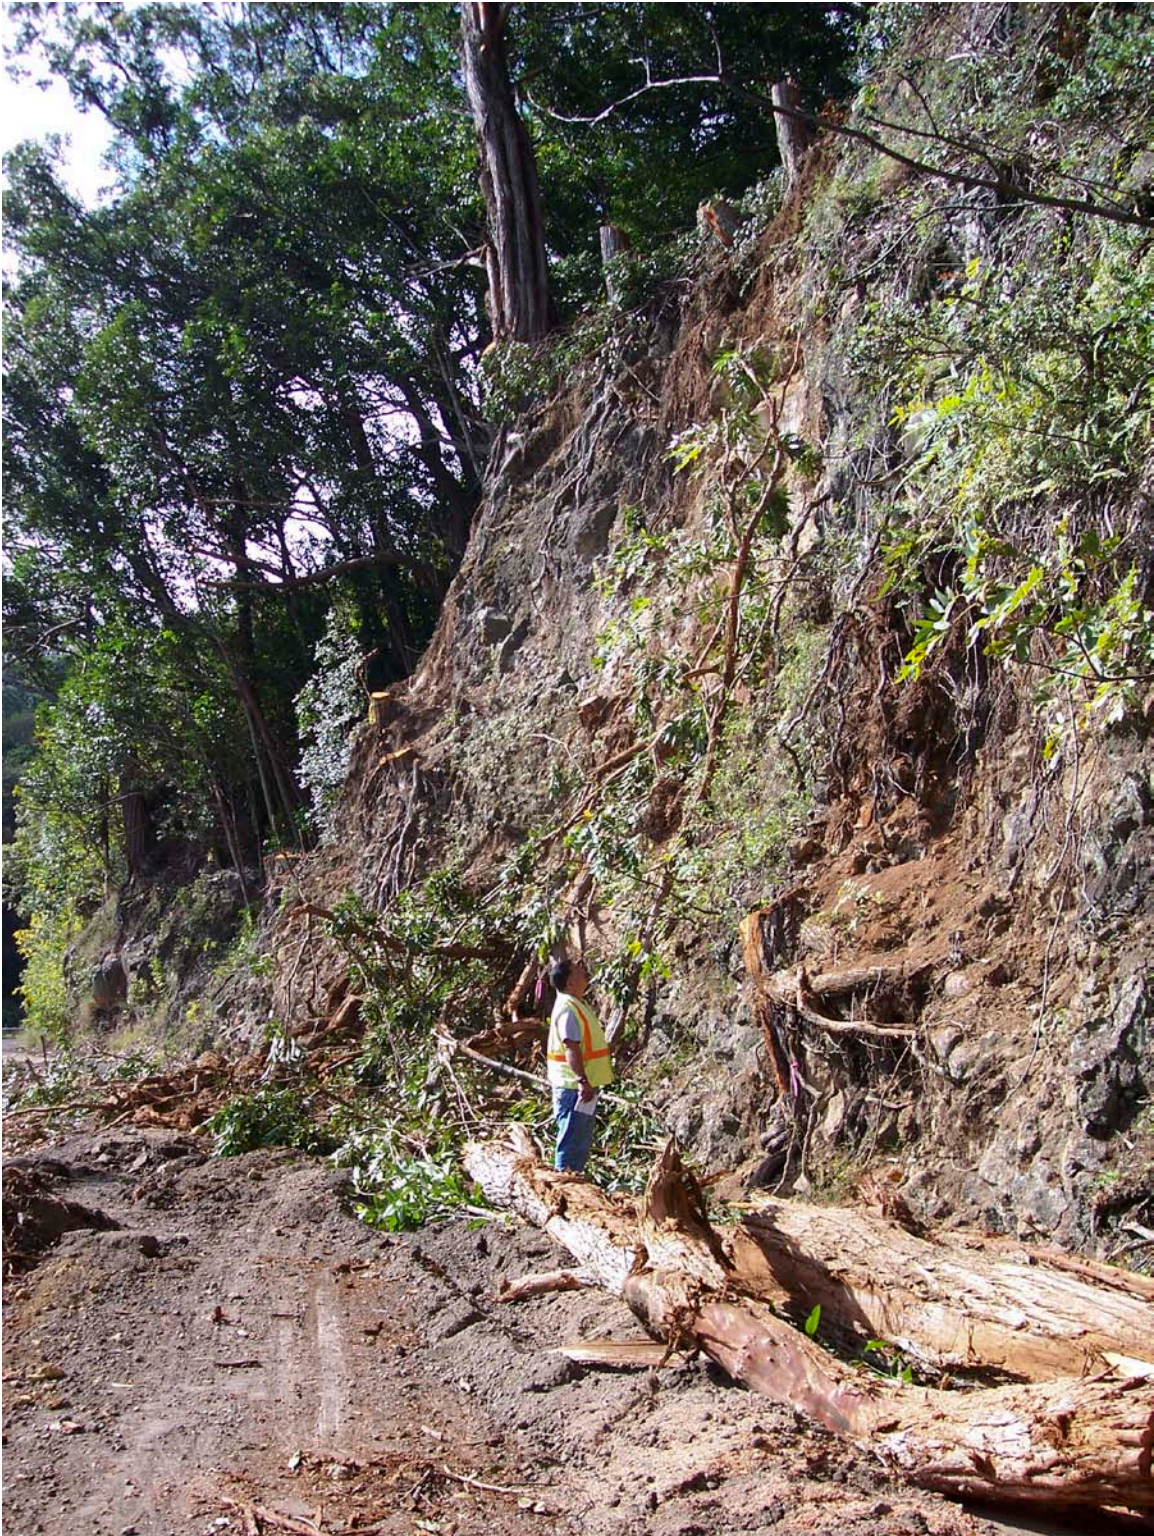
7.2. View of trees pruned from the cliffside to reduce hazard to motorists (view to the south). USGS photo by T.J. Takahashi, 12/22/2006 (tjt2177).

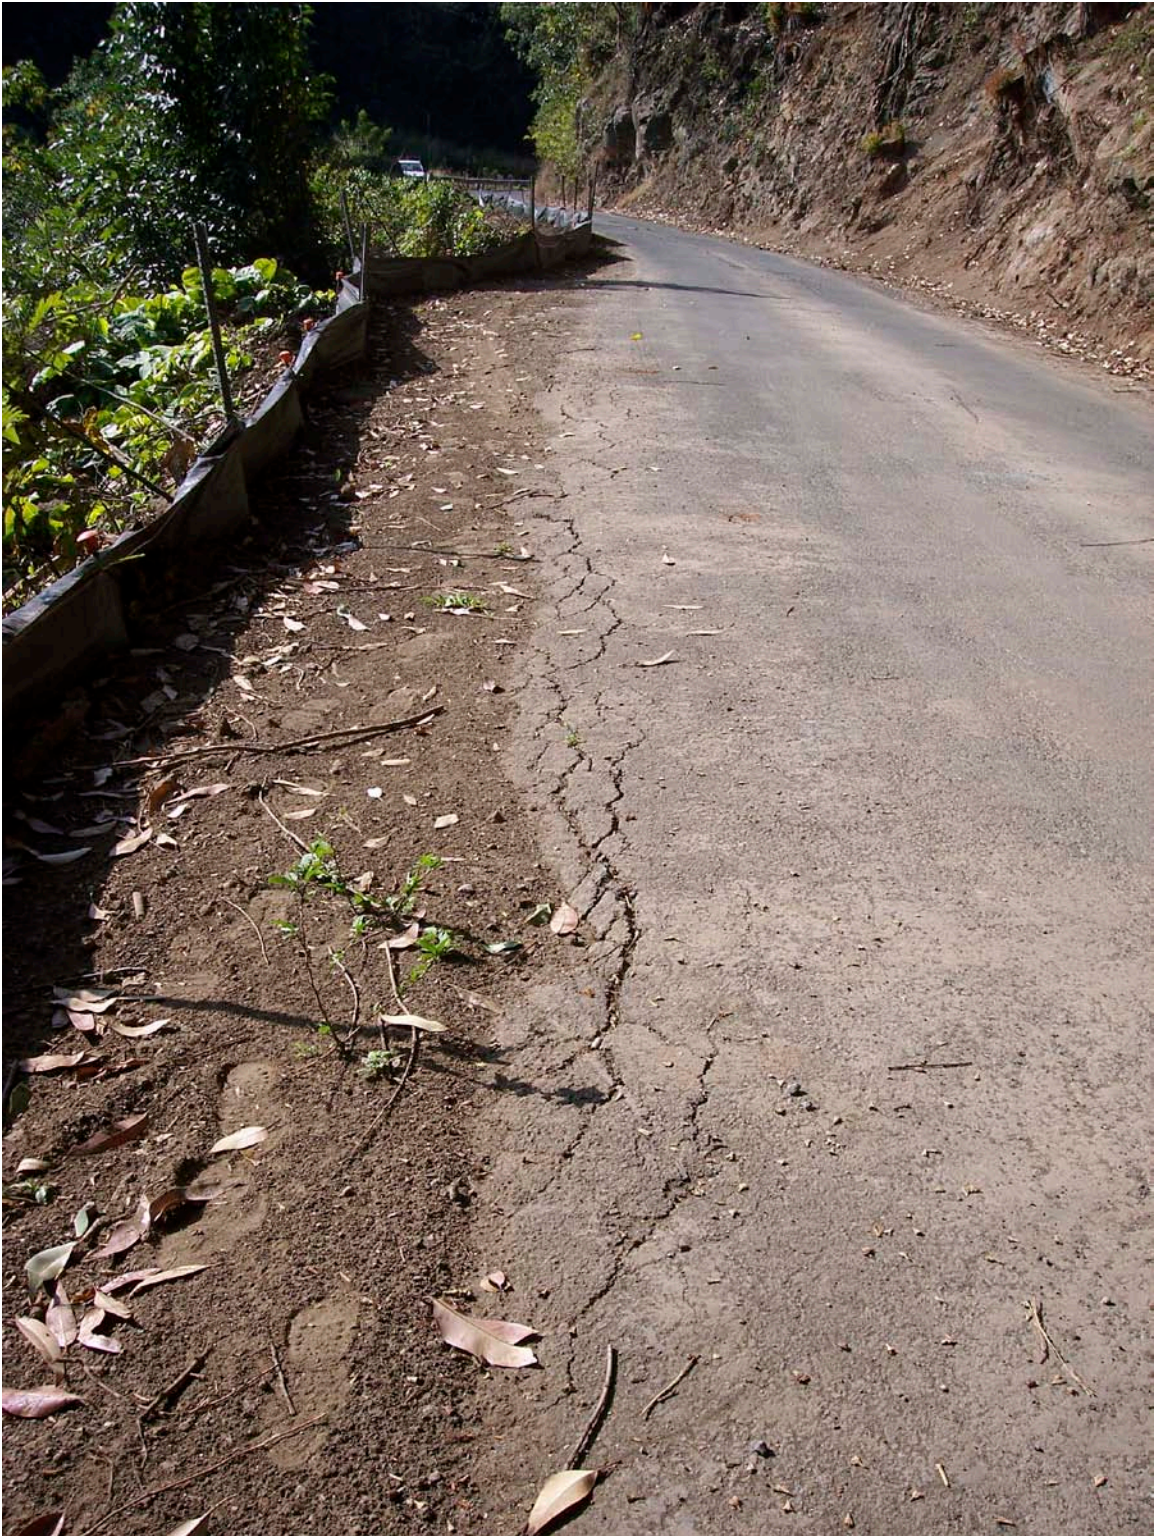
7.7. View of cracks alongside the road and barrier marking the failed slope (view to the south). USGS photo by T.J. Takahashi, 2/4/2007 (tjt2351).

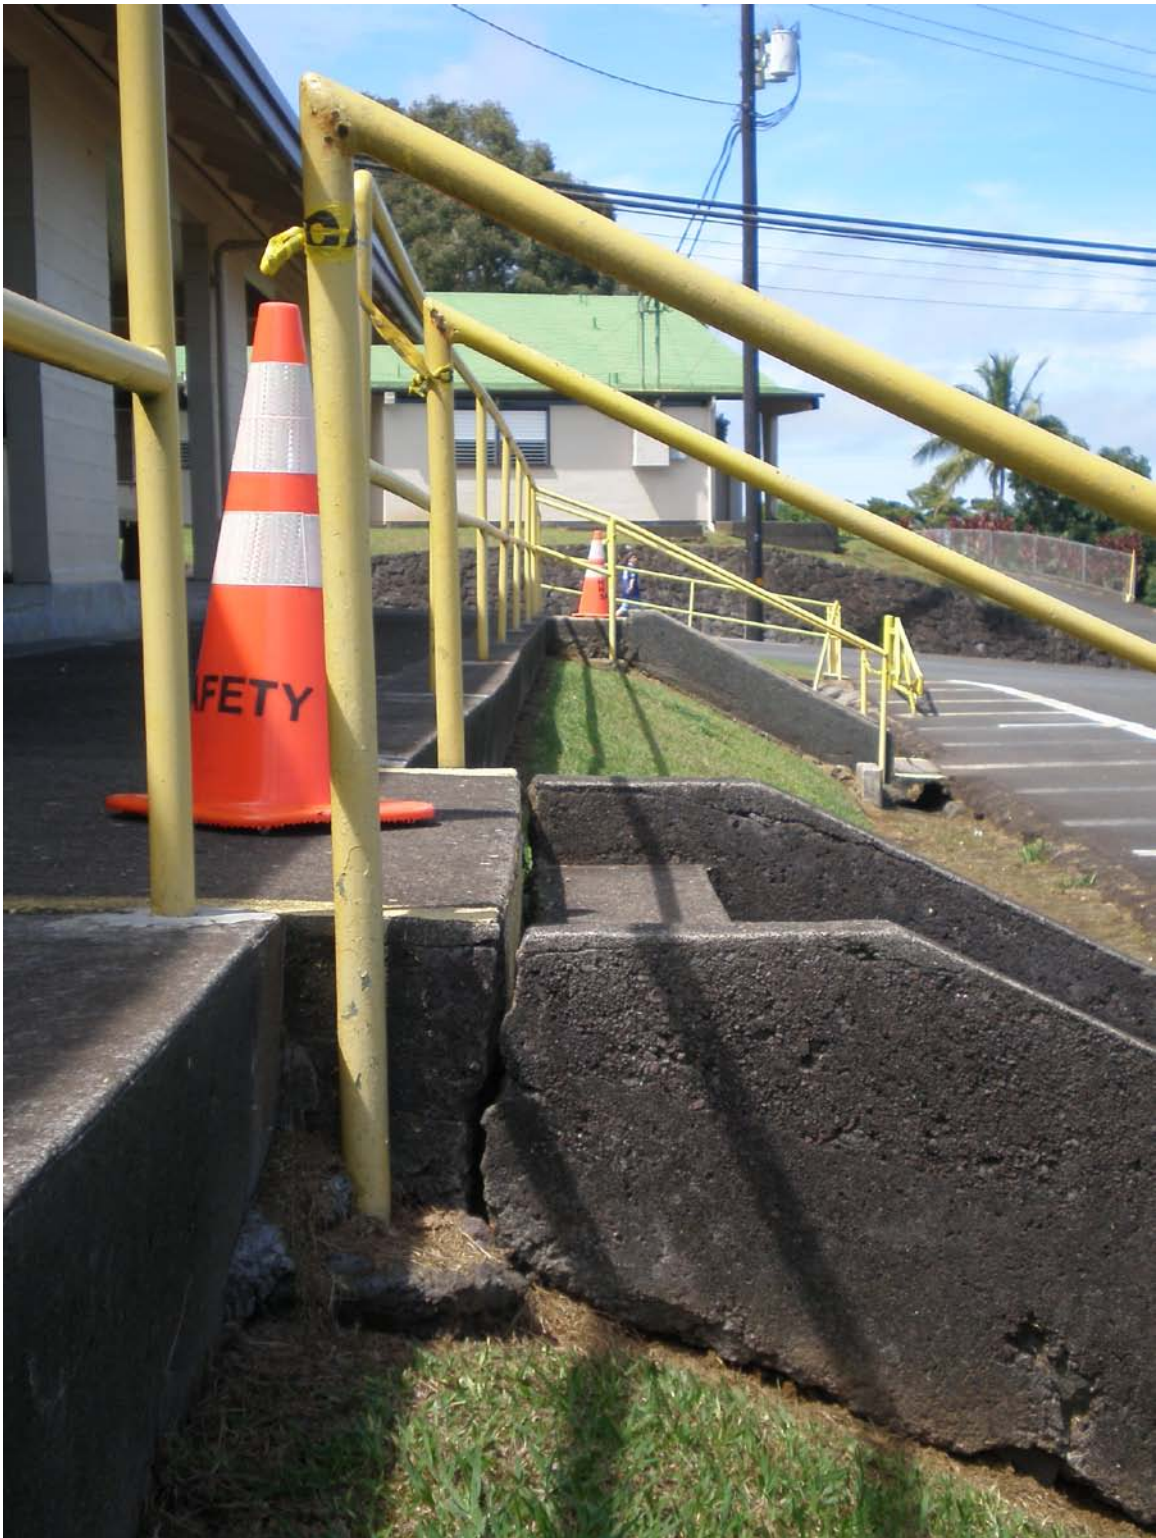
8.2. View of concrete stairs that cracked and separated from the main walkway (view to the northwest). USGS photo by C. Francos, 10/17/2006 (cf023).

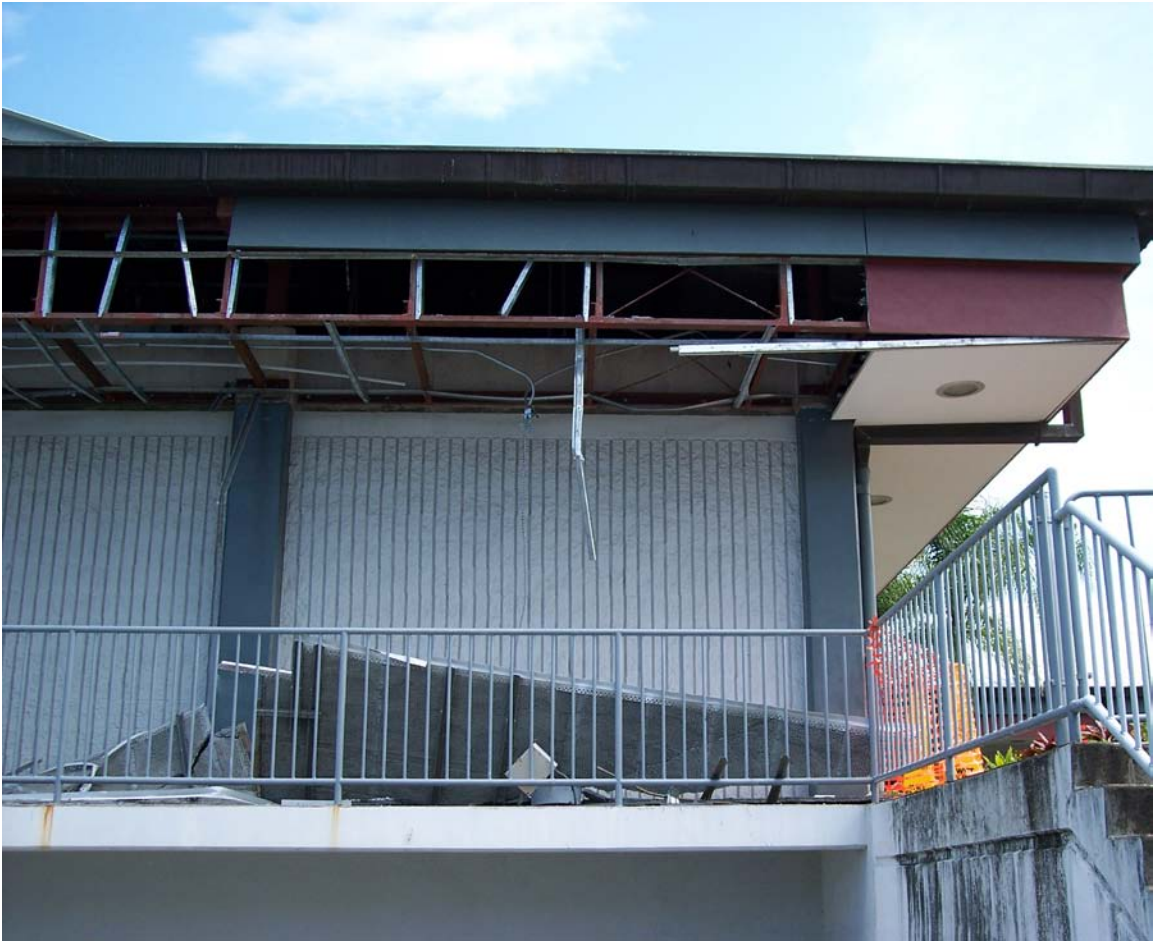
9.3. View of the most extensive damage, which occurred from fallen stucco panels and their steel supports under the eaves (view to the southwest). USGS photo by T.J. Takahashi, 10/20/2006 (tjt1336).
